# Fire Door Inspection Report

Ref: FD-00009 · Issued: 25 Jun 2026 · Review: 25 Jun 2027

# Oakwood Court

**FD-00009**

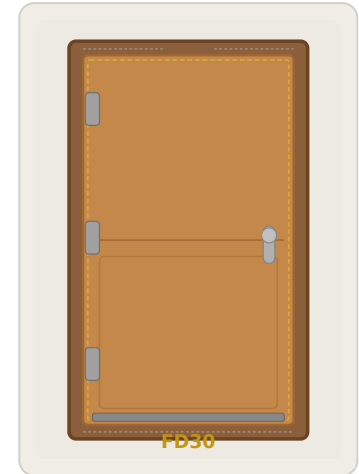
Black-finished timber FD30 doorset. Leaf, frame, hinges, intumescent/smoke seals, latch ironmongery and perimeter gaps inspected and compliant. No overhead closer, vision panel, threshold seal, hold-open or signage - marked N/A.

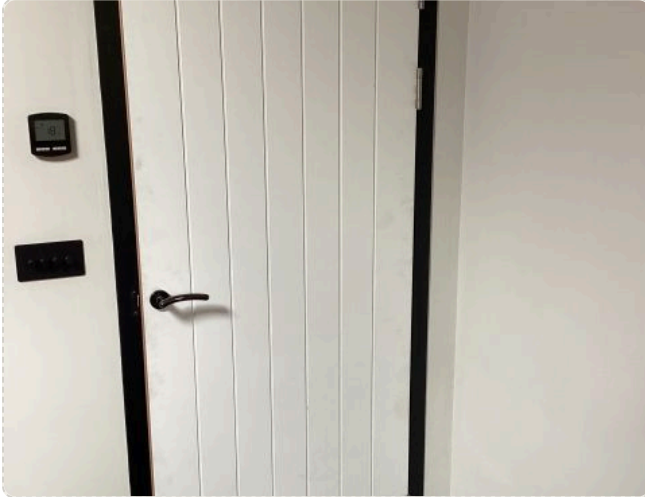
Gaps · PASS · Low

| COMPONENT | STATUS | SEVERITY | NOTES |
|---|---|---|---|
| Gaps | <b>PASS</b> | Low | Perimeter gaps around the leaf within the 3-4mm tolerance. |

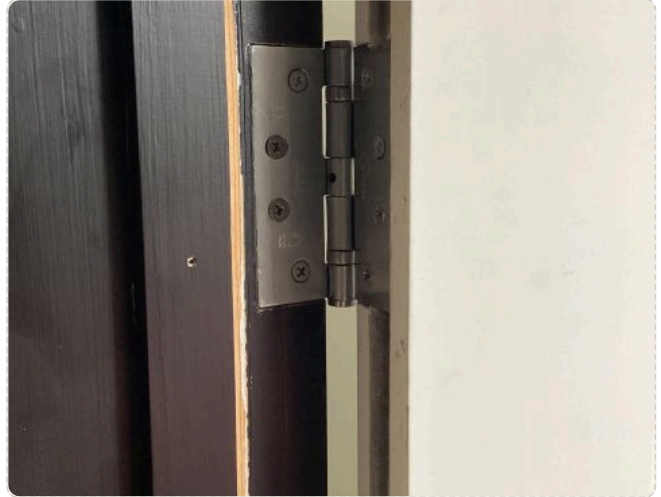
Hinges · PASS · Low

| COMPONENT | STATUS | SEVERITY | NOTES |
|---|---|---|---|
| Hinges | <b>PASS</b> | Low | CE-marked fire-rated hinge (BS EN 1935), secure with no missing screws. |

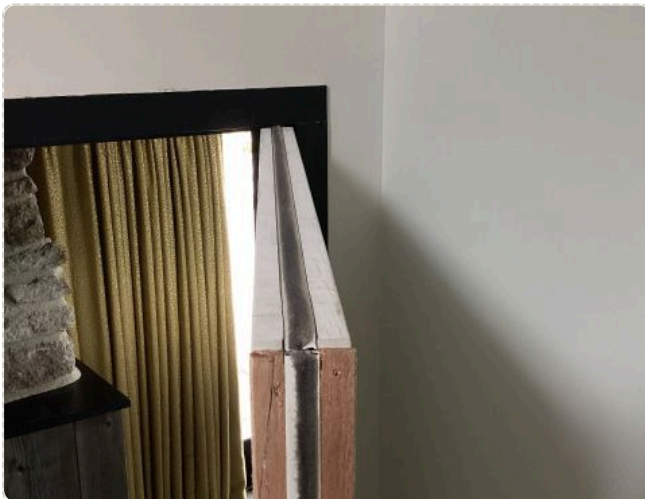
Intumescent strips / seals · PASS · Low

| COMPONENT | STATUS | SEVERITY | NOTES |
|---|---|---|---|
| Intumescent strips / seals | <b>PASS</b> | Low | Intumescent / cold-smoke seals continuous around the leaf. |

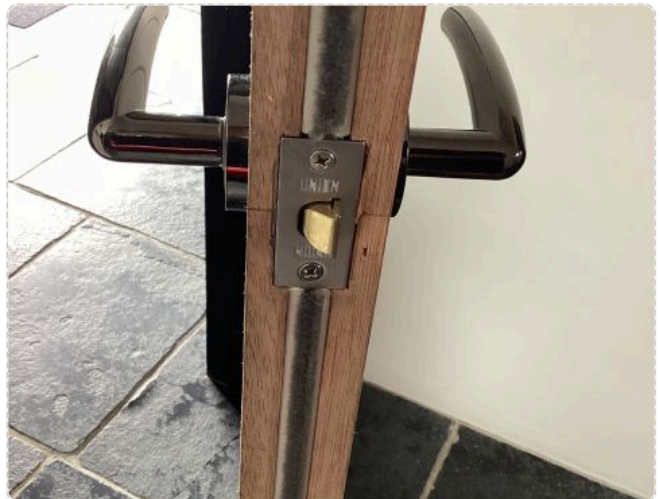
Ironmongery / locks · PASS · Low

| COMPONENT | STATUS | SEVERITY | NOTES |
|---|---|---|---|
| Ironmongery / locks | <b>PASS</b> | Low | Latch and lever furniture (UNION) operate correctly and hold the leaf closed. |

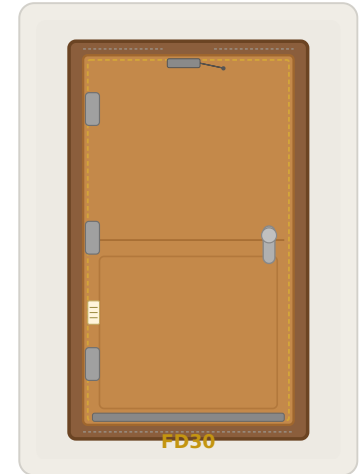
Cream shaker FD30 flat-entrance doorset with an overhead closer. Leaf, frame, hinges (with continuous seals), closer, perimeter gaps, ironmongery and certification label inspected and compliant. No vision panel, hold-open or signage - marked N/A.

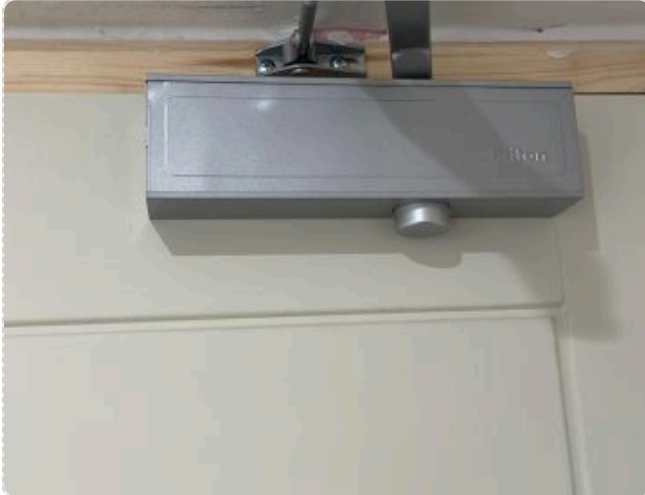
Closer · PASS · Low

| COMPONENT | STATUS | SEVERITY | NOTES |
|---|---|---|---|
| Closer | PASS | Low | Briton overhead closer pulls the door to full latch from any angle. |

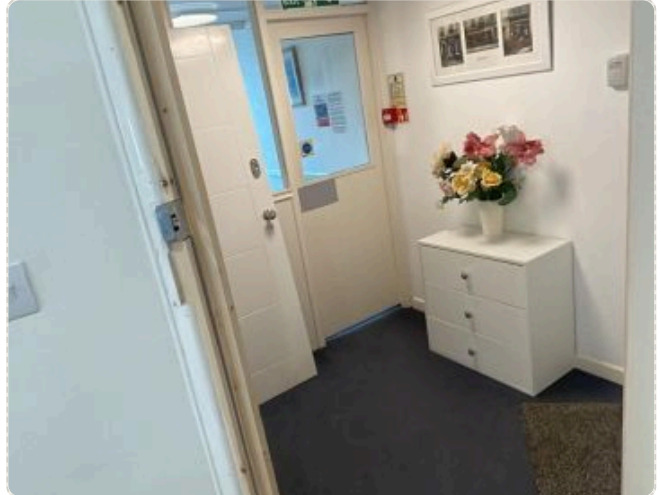
Frame · PASS · Low

| COMPONENT | STATUS | SEVERITY | NOTES |
|---|---|---|---|
| Frame | PASS | Low | Frame correctly lined, packed and fixed to the structure. |

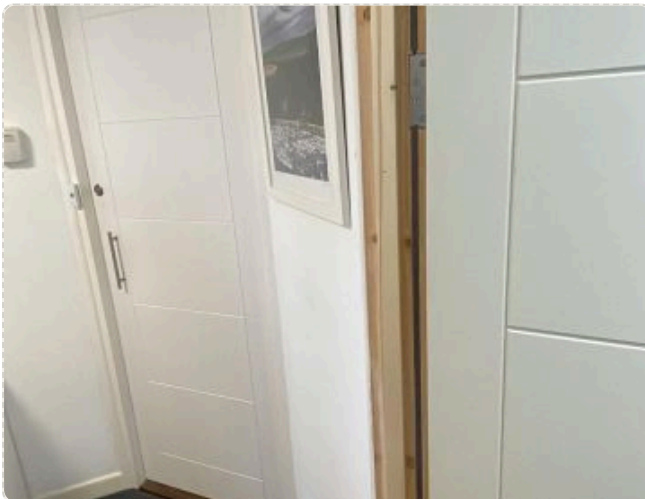
Hinges · PASS · Low

| COMPONENT | STATUS | SEVERITY | NOTES |
|---|---|---|---|
| Hinges | PASS | Low | CE-marked fire-rated hinges secure; intumescent seals continuous at the hinge stile. |

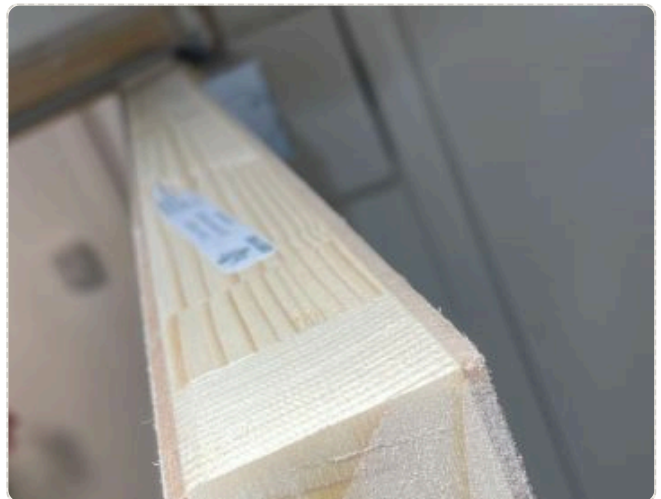
Certification labels · PASS · Low

| COMPONENT | STATUS | SEVERITY | NOTES |
|---|---|---|---|
| Certification labels | PASS | Low | Fire door certification / inspection label present and legible. |

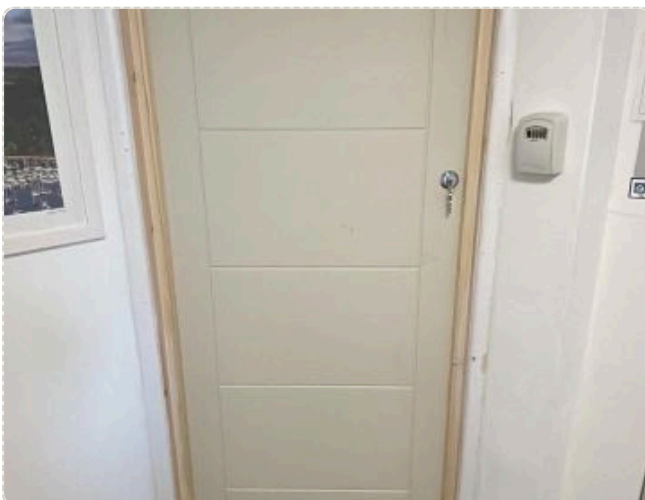
Leaf · PASS · Low

| COMPONENT | STATUS | SEVERITY | NOTES |
|---|---|---|---|
| Leaf | PASS | Low | Cream shaker leaf, undamaged, correctly hung in a new lined frame. |
