# Fire Door Inspection Report

Ref: FD-00009 · Issued: 25 Jun 2026 · Review: 25 Jun 2027

# Oakwood Court

**FD-00009**

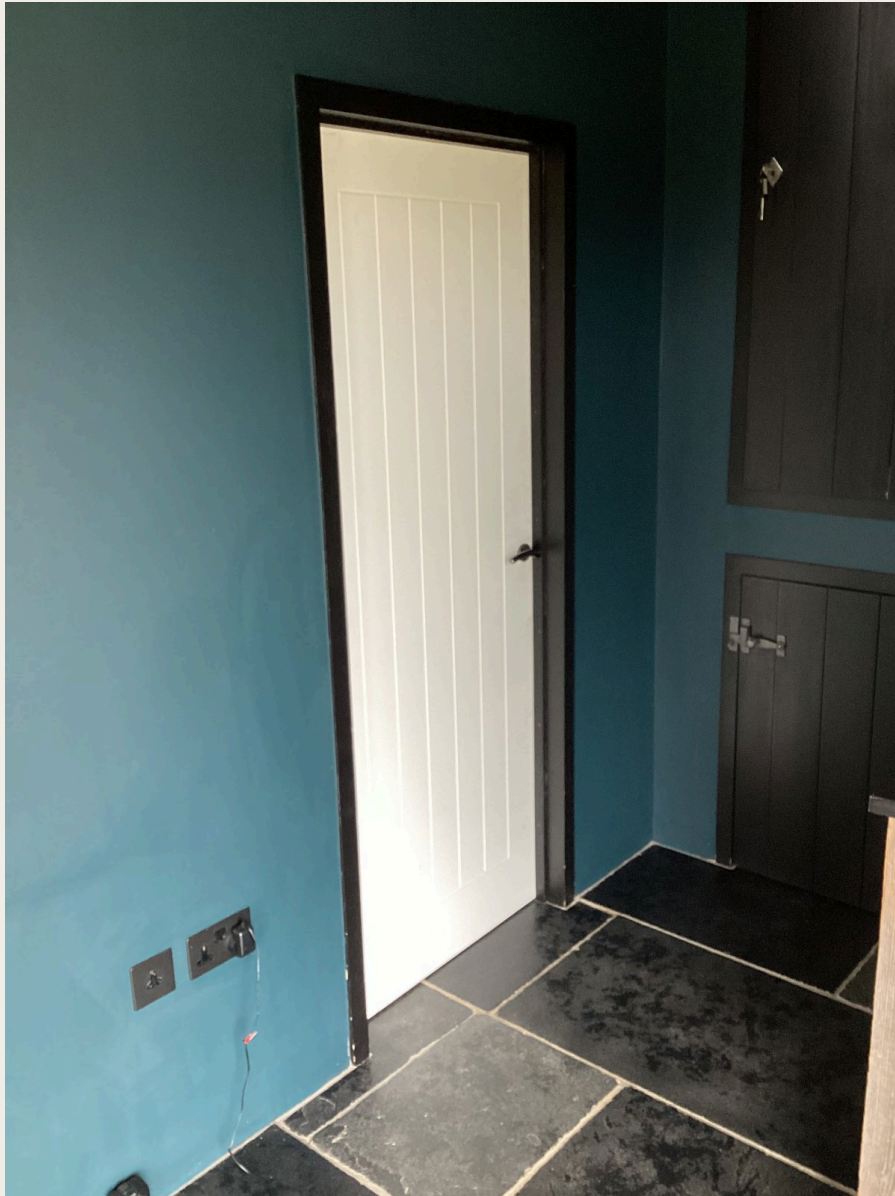
1

Black-finished timber FD30 doorset. Leaf, frame, hinges, intumescent/smoke seals, latch ironmongery and perimeter gaps inspected and compliant. No overhead closer, vision panel, threshold seal, hold-open or signage - marked N/A.

PASS / Low
